Company Name: **Leopalace21 Corporation**
 Representative: Eisei Miyama, President and CEO
 Code Number: 8848 (Tokyo Stock Exchange, First Section)
 Contact: Bunya Miyao, Director
 Tel: +81-50-2016-2907
 E-mail: ir@leopalace21.com

**Progress Report of All-building Investigations and
Notice Concerning Newly Confirmed Construction Defects**

[Appendix 1] All-building investigation progress as of January 28, 2019

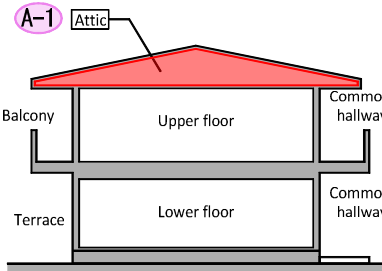
No parting wall in entire attic

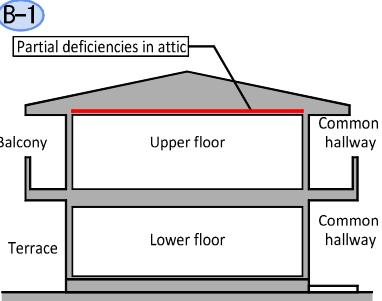
Partial deficiencies in attic

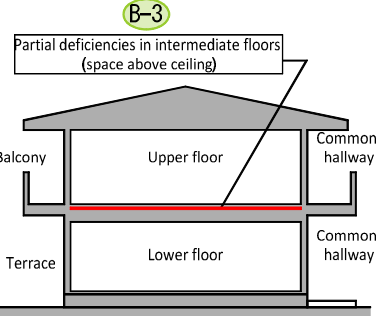
Partial deficiencies in intermediate floors (space above ceiling)

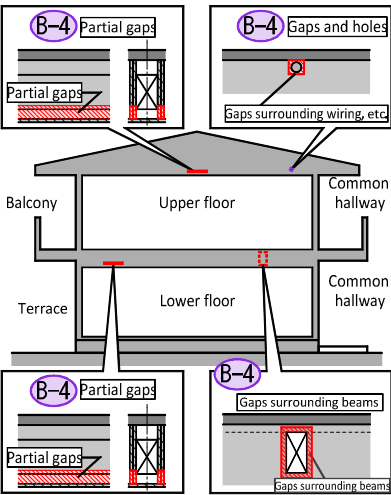
Partial gaps Gaps and holes Gaps surrounding wiring, etc. Partial gaps Gaps surrounding beams

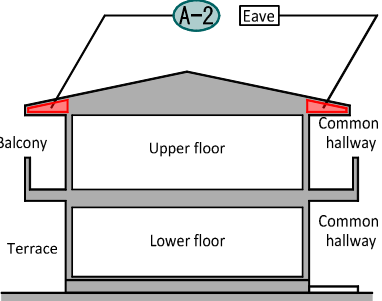
No parting wall in eave only

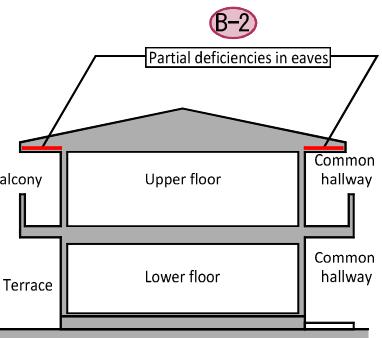
Partial deficiencies in eaves

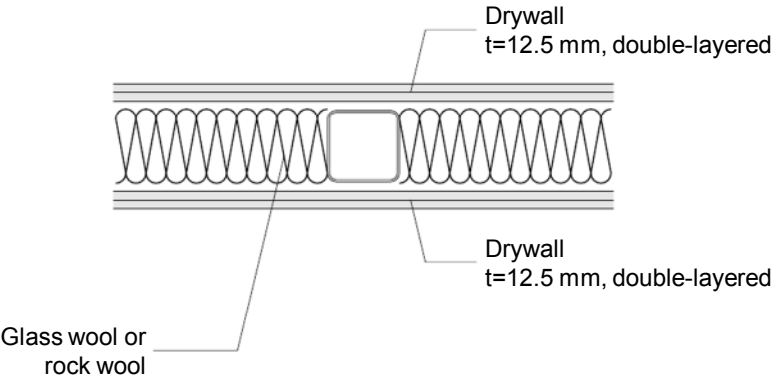
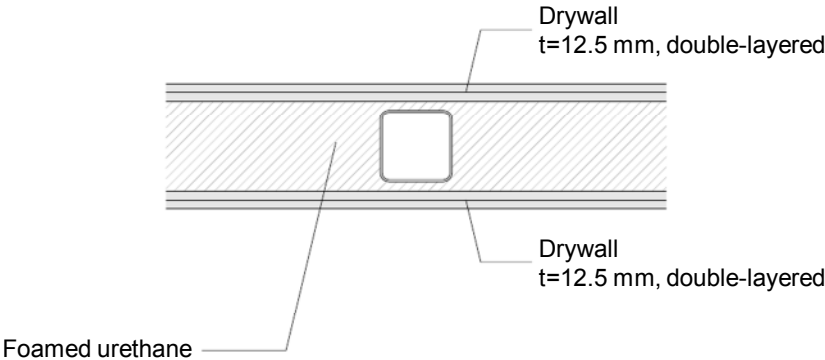
Appendix 2. Specifications of walls with foamed urethane (parting wall)

During the course of all-building investigations, we confirmed certain discrepancies in parting walls of Gold Residence and New Gold Residence series (both subject to top priority investigations, “GR” and “NGR”) constructed between June 12, 1996 and September 17, 2001. Discrepancies were confirmed in certain buildings constructed in 16 prefectures of Japan. Although it is written in construction certification documents that glass wool (fiberglass) is to be used as insulation material in parting walls, we confirmed that foamed urethane was used in certain buildings. There is a possibility that these buildings do not meet the sound insulation standards of apartments required by the Building Standard Law. “Foamed urethane was used” means that the installed wall panels (“subject panels”) were filled with foamed urethane. The foamed urethane was used as an insulation material.

At that time, the Ministry of Construction Notice No. 1827 (issued in 1970) required glass wool or rock wool to be used as insulation material in parting walls. However, since foamed urethane was recognized as a superior material in terms of insulation performance and price (foamed urethane is more expensive), we wrongly assumed that it met notice requirements.

Currently, we are considering adding a layer from the inside of the room to repair ceilings and parting walls. We will consult with apartment owners and designated administrative agencies and decide the method and content of repairs.

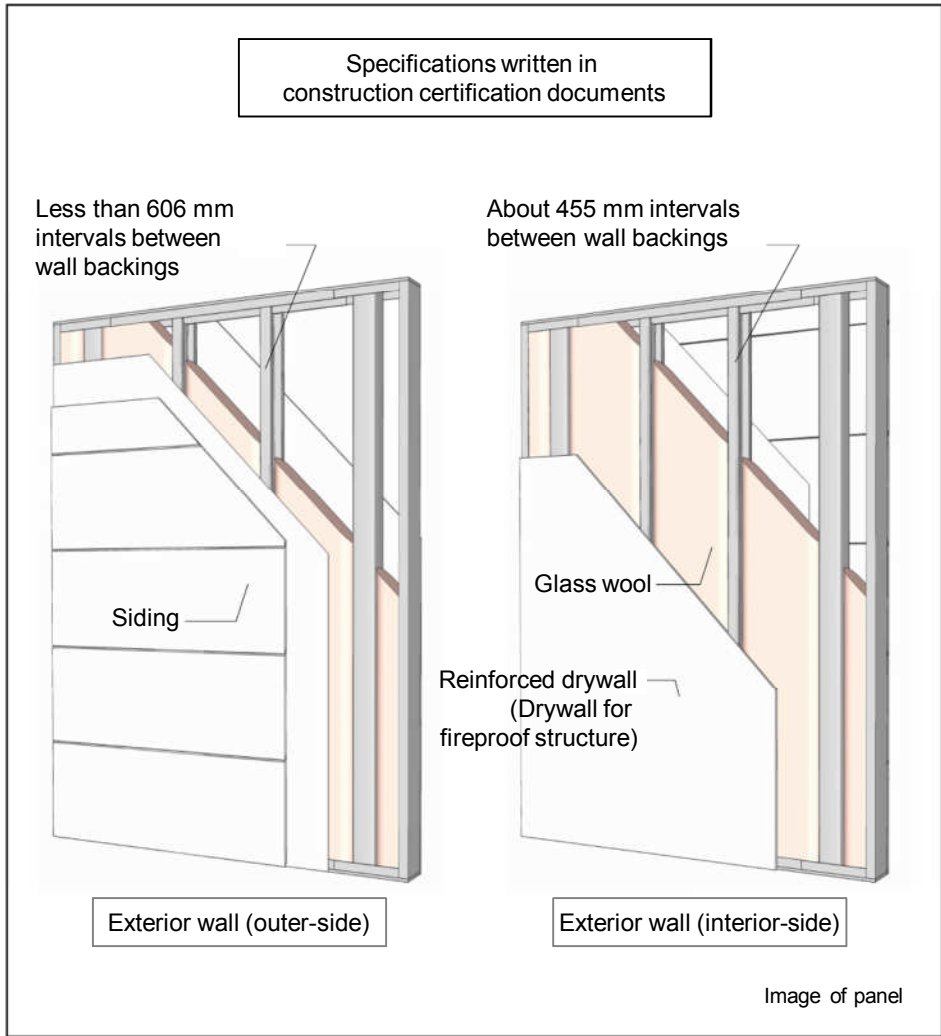
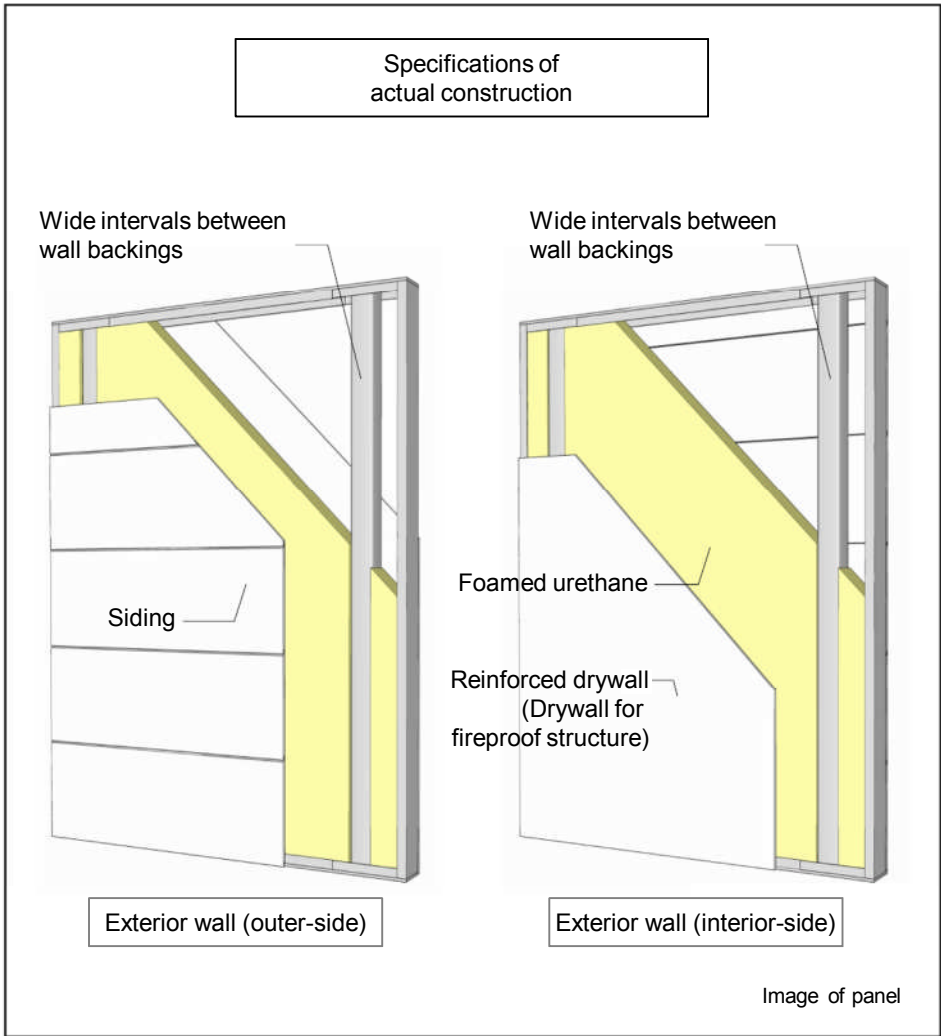
Appendix 3. Specifications of walls with foamed urethane (exterior wall)

We confirmed that subject panels (noted in Appendix 3) were installed in exterior walls of “GR”, “NGR”, and Villa Alta (not subject to top priority investigations, “AGR”) series constructed in 16 prefectures between September 14, 1999 and February 9, 2001. According to the Building Standard Law, exterior walls of apartments require semi-fire-resistant or fireproof structures. However, we confirmed that certain buildings with the subject panels installed do not meet qualifications certified by the Minister of Land, Infrastructure and Transport^{*1}, as noted in construction certification documents.

The binding method of boards and the necessary length between wall backings is specified in qualifications certified by the Minister of Land, Infrastructure and Transport. However, we believe communication between the designing department and the product ordering department was insufficient, leading to the manufacturing of subject panels with specifications different from those specified in the qualifications.

For exterior walls, we are considering repairs to match qualifications certified by the Minister of Land, Infrastructure and Transport, and will consult with apartment owners and designated administrative agencies. At the same time, we will check whether or not we can acquire the qualifications.

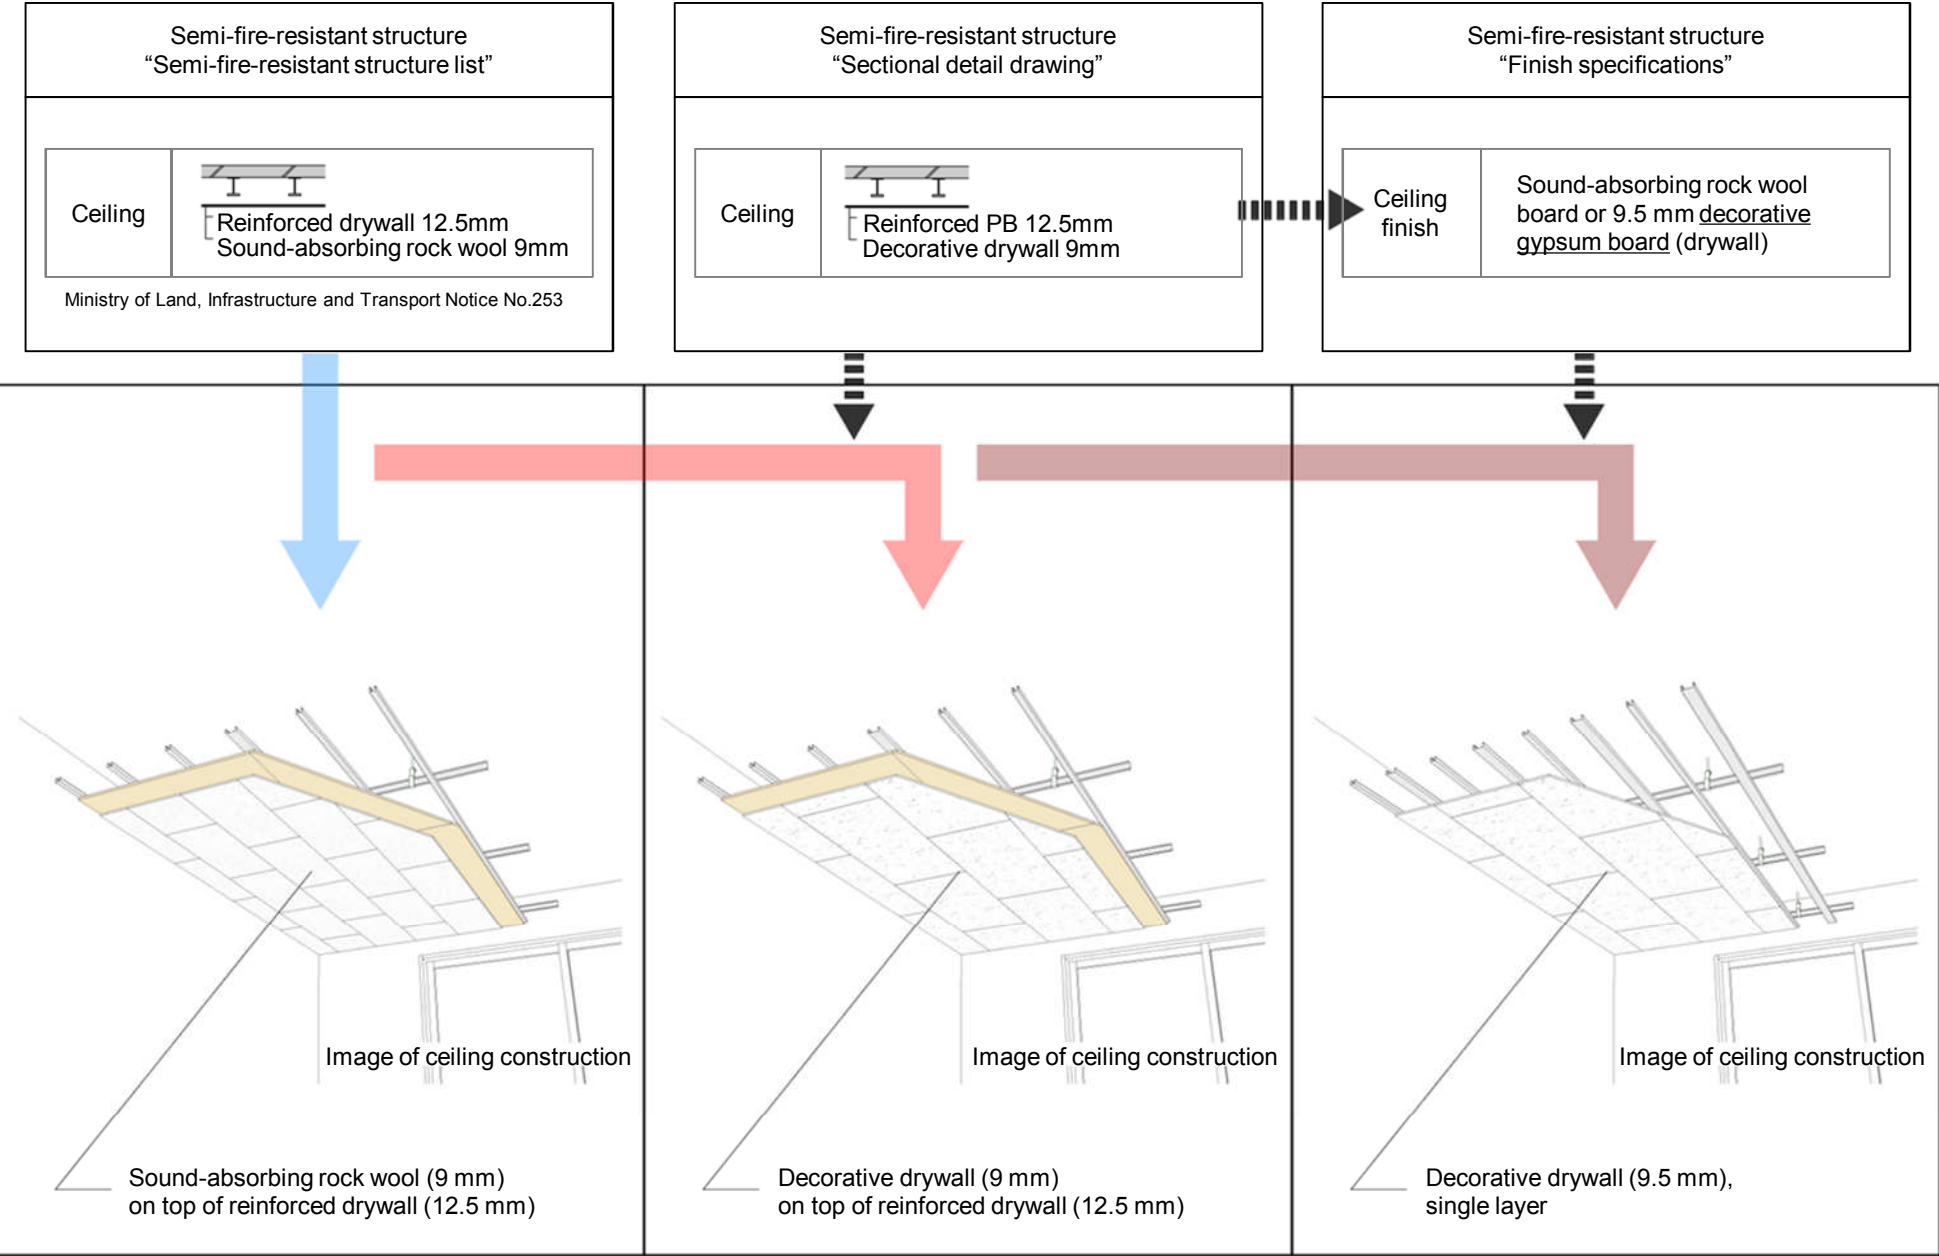
Appendix 4. Ceiling specifications of three-story Gold Residence with semi-fire-resistant structure

During the course of all-building investigations, we confirmed defects in ceilings (ie. living space floors) of “GR” series constructed between March 16, 1996 and January 22, 2001. Defects were confirmed in certain buildings constructed in 32 prefectures of Japan. According to the Building Standard Law, floors of three-story apartments require one-hour semi-fire-resistant structures, with double layers using materials specified in construction certification documents. However, we confirmed single-layered ceilings as well as double-layered ceilings with non-specified materials.

In the finish specifications included in construction certification documents, it is written that “semi-fire-resistant specifications are stated in the ‘semi-fire-resistant structure list.’” In the semi-fire-resistant structure list, it is written that the materials used for ceilings should be “12.5 mm reinforced gypsum board (drywall) + 9 mm sound-absorbing rock wool board.” However, in the sectional detail drawing, it is written that materials used for ceilings should be “12.5 mm reinforced PB + 9 mm decorative board (drywall).” In the finish specifications, it is written that materials for ceilings should be “sound-absorbing rock wool board or 9.5 mm decorative gypsum board (drywall).” We believe these inconsistent and misleading expressions have resulted in misunderstandings, thus leading to construction defects. In addition, the decorative board and the sound-absorbing rock wool board are similar in appearance, and it is also not clear from the outside whether there is one layer or two layers after the ceiling is finished. Due to these factors, it is highly probable that construction supervision failed to indicate any inadequacies. Therefore, we believe that inadequate use of decorative boards on ceilings was not corrected and constructions were carried out.
