Measures against construction defects of
properties constructed by Leoplace21

Typification and outline of construction defects / Outline of the series of deficient properties

Overview of Parting Wall Construction Defects

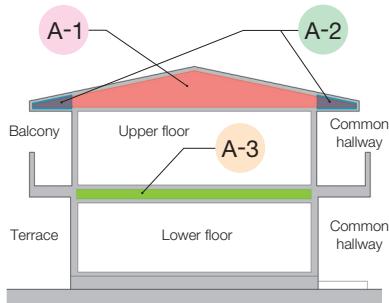
■ No parting wall (A-1~3)

No parting wall at any point in the attic

No parting wall in eaves

No parting wall in intermediate floors (space above ceilings)

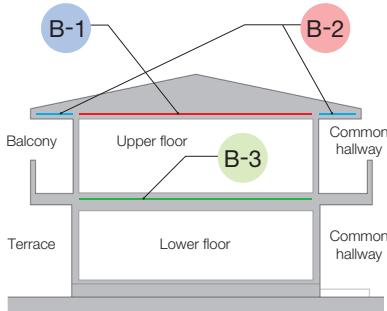
■ No defects (B-1~3)

Partial defects in attic

Partial defects in eaves

Partial defects in intermediate floors (space above ceilings)

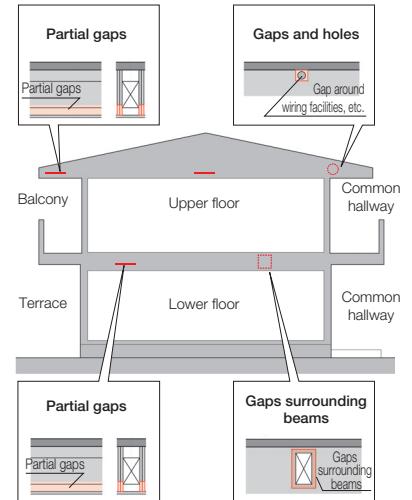
■ Minor defects

Defects in work concerning gaps and holes in attics and Intermediate floors (space above ceilings)

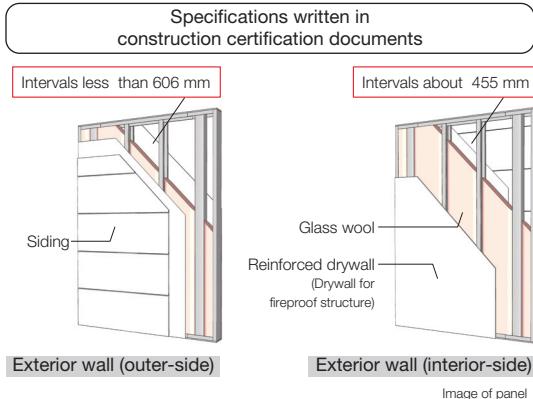
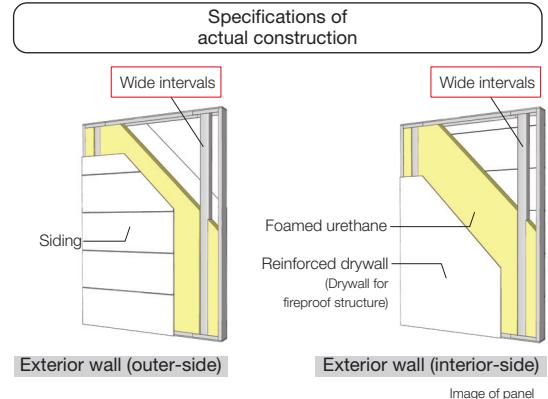
■ Exterior Wall Structures not Meeting Specifications Required for Certification by the Minister of Land, Infrastructure and Transport

According to the Building Standards Act, exterior walls in apartments are required to be semi-fire-resistant or fireproof. However, we confirmed that certain buildings in which the panels are installed do not meet the specifications required for certification by the Minister of Land, Infrastructure and Transport, as noted in design drawings.

Since foamed urethane was used as an adhesive to bind sidings and reinforced drywall, the intervals between wall backings became wider than the required specifications.

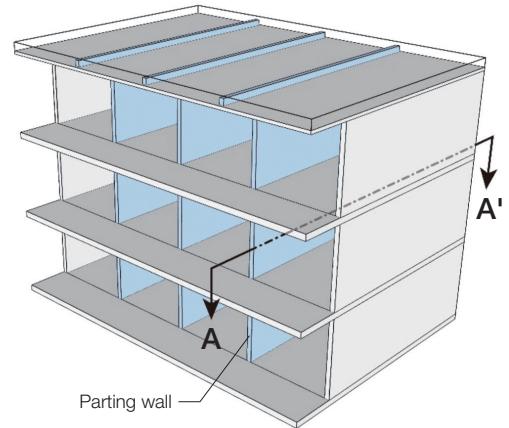
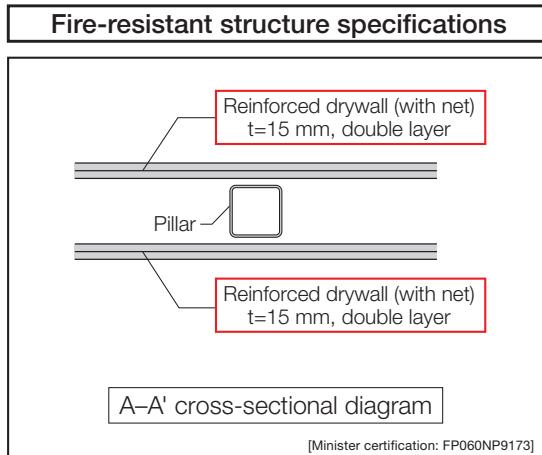
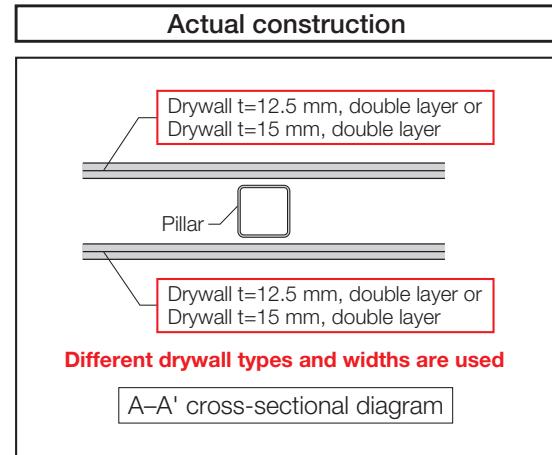
■ Position of parting wall

Of the 2,240 buildings constructed as fire-resistant properties, on-site investigations were conducted on 204, of which 63 were confirmed to be properties whose specifications do not comply with the Building Standards Act, stating that parting walls must be fire-proof structures. We believe 62 out of the 63 buildings comply with 2015 Ministry of Land, Infrastructure and Transport Notice No. 253, which meet one-hour semi-fire-resistant performance.

We confirmed one of the 63 buildings does not meet one-hour semi-fire-resistant performance, or sound-insulation specifications certified by the Minister of Land, Infrastructure, and Transport.

This specification does meet one-hour semi-fire-resistant performance.

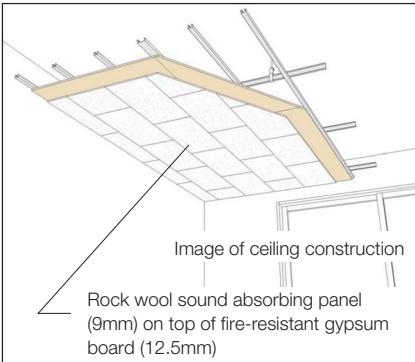
<p>Image of ceiling construction</p> <p>Rock wool sound absorbing panel (9mm) on top of fire-resistant gypsum board (12.5mm)</p>

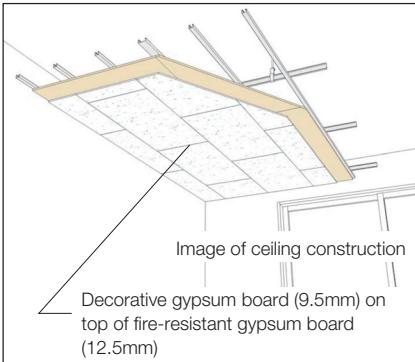
<p>Image of ceiling construction</p> <p>Decorative gypsum board (9.5mm) on top of fire-resistant gypsum board (12.5mm)</p>

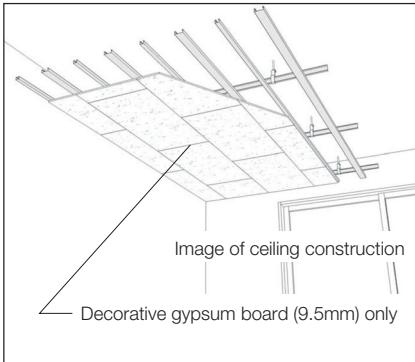
<p>Image of ceiling construction</p> <p>Decorative gypsum board (9.5mm) only</p>
