Measures against construction defects of
properties constructed by Leoplace21

Typification and outline of construction defects / Outline of the series of deficient properties

Overview of Parting Wall Construction Defects

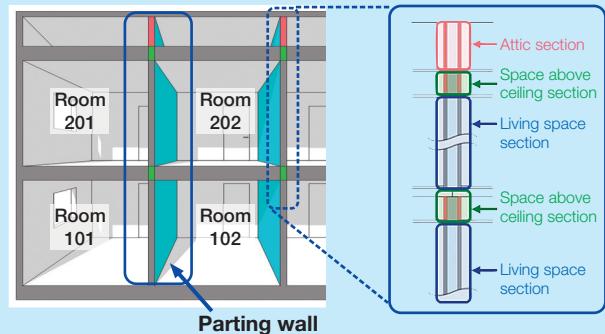
Parting walls are walls that separate dwelling units (rooms) in apartment buildings.

These walls must fulfill meet technical standards relating to sound insulation and fireproofing established by the Building Standards Act and other related laws and regulations, and must reach attics or spaces above ceilings.

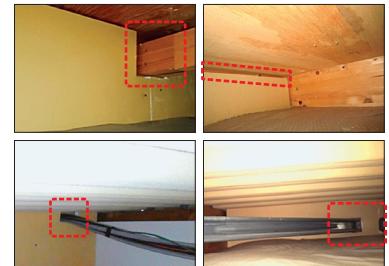
Attics and Intermediate floors (space above ceilings)

Defects in work concerning gaps and holes in attics and Intermediate floors (space above ceilings)

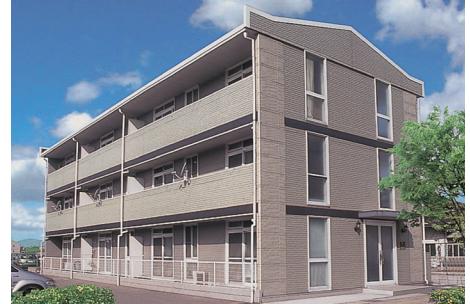
Gold Residence (GR), Three-stories

We checked construction drawings and specifications for all apartment series and have confirmed that only construction drawings and specifications for three-story “GR” contain misleading notations. Properties that may be defective are limited to three-story “GR” with one hour semi-fire-resistant structures. There are a maximum of 641 such buildings nationwide.

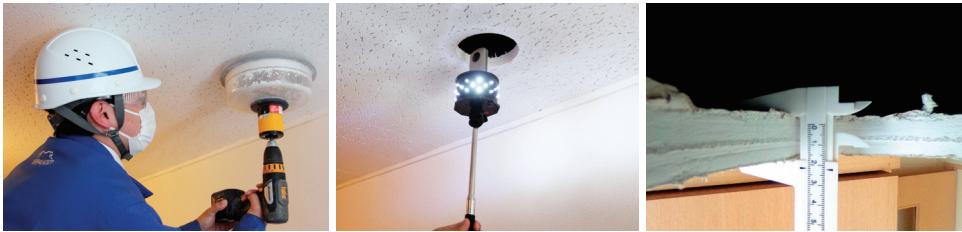
① Investigation about the parting wall in attic, spaces above ceilings.

Open the ceiling and check the construction condition of the parting wall.
In addition, check the specifications and thickness of the ceiling from the opening.

Shoot with a 360 ° camera from the open ceiling.

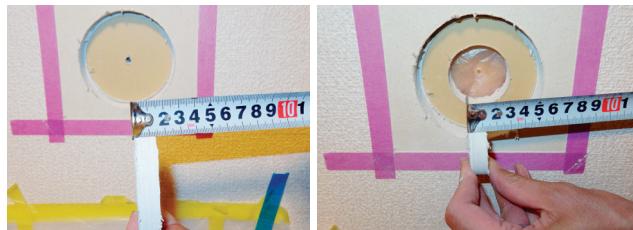
③ Investigation about internal outer wall.

Open the outer wall and check the insulation and wall thickness inside.

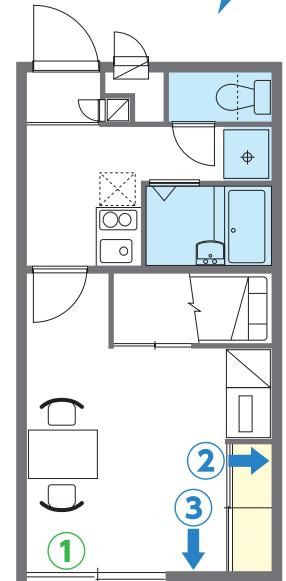
Survey point

Note: Survey points vary depending on the property type.
